# Replacing Rotted Sills

It's a dirty job, but somebody's got to do it

by George Nash

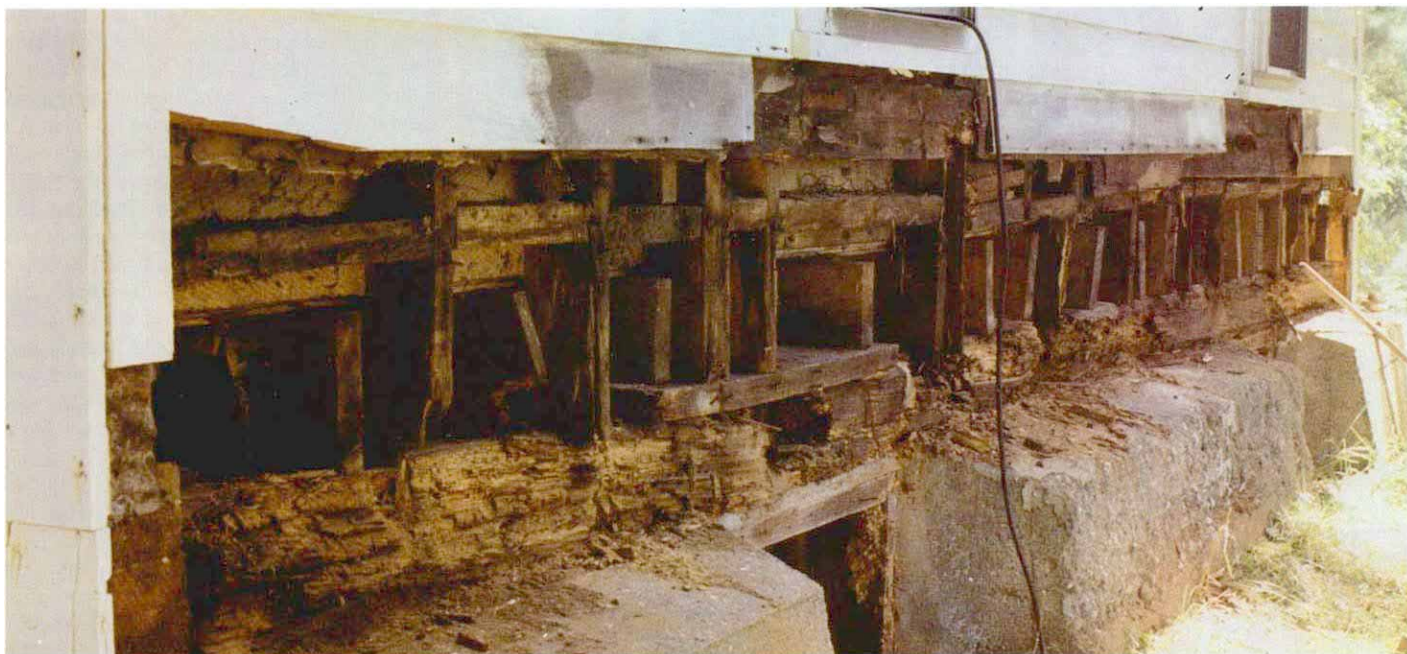
**When probed with an awl from inside, the sills pictured above felt solid, but mildew and signs of decay on the clapboards outside suggested otherwise. The concrete wall, used to buttress the old stone foundation, had no flashing or drip cap on top of it, so water seeped behind the wall and into the sills, joists and studs.**

With a nail-eating carbide blade in the circular saw, I sawed along the bottom edge of the sixth course, removing all the siding below the window sills. Feeling like a surgeon probing a malignant cancer, I removed the sheathing boards. What remained of the timber sill would have made an excellent medium for growing mushrooms. The decay had progressed into the ends and bottom edges of floor joists that rested on the sill and continued up into the bottom of the wall studs (photo above).

The irony of all this is that the damage and subsequent repair work could have been avoided if a drip cap or simple flashing had been installed when the buttress wall was poured. Why this was not done eludes me. Perhaps it was ignorance or laziness, but I have seen many such walls over the years, and except for a desiccated bead of caulk between clapboard and concrete, nothing protected this problem zone.

The buttress wall had been poured directly against the siding, forming an exquisite water trap. The old building paper soaked up moisture like a paper towel and held it against the sheathing. Ventilation was discouraged by the painted siding, which was relatively rot-resistant red cedar. A more ideal environment for decay-producing fungi would be hard to build. Thus the rot grew inward, first through the sheathing boards, then into the framing. The sills were hardest hit because they rested on masonry, which tends to draw water.
