Replacing a Mudsill

Careful bracing inside and out holds a house steady as rot is removed

BY BILL PHILLIPS

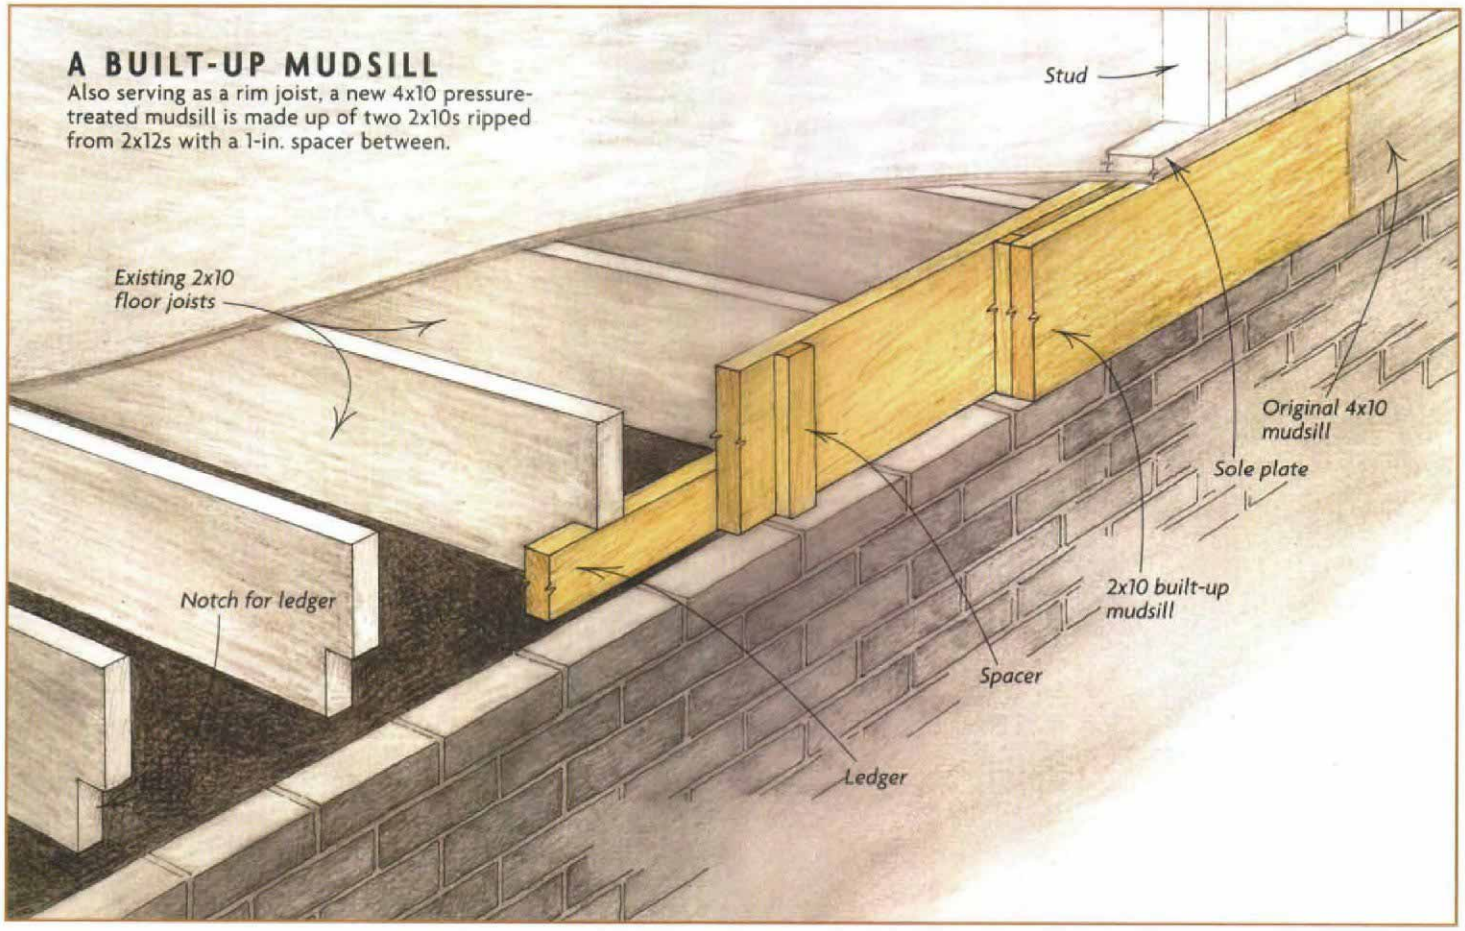
Our clients were people like the young woman, a first-time homeowner, who called a home inspector when she noticed a piece of deteriorating siding. She had bought the house assuming that it was solid, and from the outside, that's just the way it looked. But the inspector found that extensive rot lay beneath the siding (photo above right). The one-piece 4x10 mudsill, which also served as a rim joist, had been badly damaged over the years from a combination of termites and a damp location near a stream. About 80% of the existing mudsill would have to come out and be replaced with new material (photo above left).

An unwelcome surprise
A homeowner noticed some deteriorating siding. Out of sight, termites had done their work. It became necessary to replace most of the mudsill, the large wooden framing member that rests directly on the foundation.

Built entirely of southern yellow pine in the 1940s or '50s, the house otherwise seemed sturdy. With relatively simple equipment, we tackled the job methodically, removing and replacing the sill one piece at a time. We raised the house with jacks and suspended it with stout braces. The house never budged as we completed repairs.
