# Adding Up

A new second story on independent footings straddles an old house

by Eric K. Rekdahl

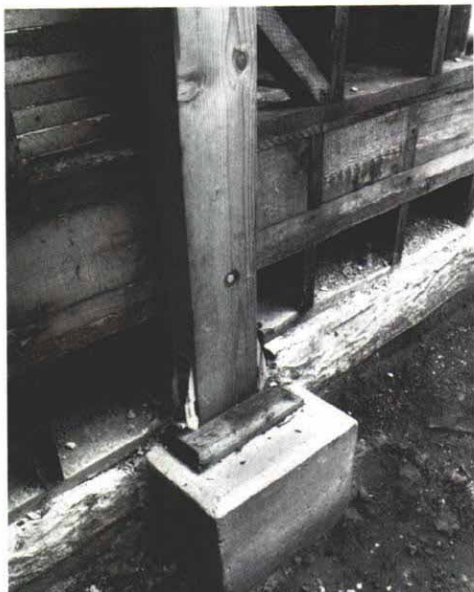
#### New piers

Simpson hold-downs  
 2x redwood sill  
 6 in. min.  
 1/2-in. by 7-in. lag screws, through 4x8 post, 2 ft. o.c.  
 10-in. J-bolts by 1/2-in.  
 18 in. min.  
 Varies from 3 1/2 ft. to 5 ft.  
 3 1/2 ft.  
 Original foundation  
 #4 rebar, 12-in. grid set in new pier

**An independent post-and-beam skeleton.** Lag-bolted to the first-floor framing, 4x8 posts rest on individual piers (drawing and photo, left). Atop the posts, 4x16 beams form a structural perimeter to hold floor joists and walls of the second story (inset, above). The badly deteriorated original stucco finish has been removed from the first-floor walls (top). They will be restuccoed. The exterior on the new second story will be board and batten.

Our structural engineer, Gene St. Onge, calculated the combined live and dead loads of the addition, and designed concrete piers to support the new load. Placement of the piers was influenced by the need to anchor the new posts to the original framing. We figured that the most likely place to find sturdy connections was the partition framing the intersections of interior walls and the exterior bearing walls.

Each pier had to extend under the existing foundation for 16 in., which meant undermining the original footing in sections up to 5 ft. in length. Before excavating for the piers, the builders removed the old roof to lessen the load on the foundation. Our guess that the stucco and sheathing on the walls would act as a beam to distribute the loads over the unsupported parts of the foundation proved to be correct. There were no problems with cracking or settling before the new concrete was poured to fill the voids.

When the builders tried to lag-bolt the posts to the existing partition studding, it became apparent that the studs we expected to tie into just weren't there. They removed the stucco to find an odd assortment of blocking, lath nailers and dry rot where we expected plate-to-plate framing. Other excavations into the stucco revealed thriving colonies of termites, so the builders removed the entire layer of stucco rather than settle for an equally costly patch job, and repaired or replaced the missing or damaged framing.
