# Double-Helix Stair

A cherry spiral built with divine inspiration,  
a little steam and a lot of clamps

by Robin Ferguson

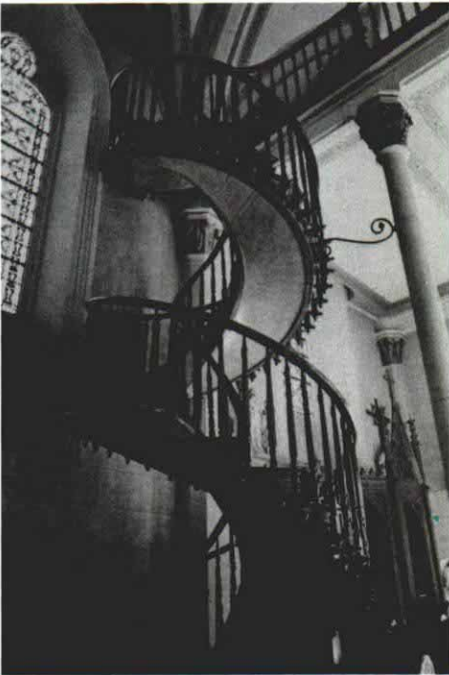
Unlike conventional spiral stairs that are supported by a central post, the cherry staircase at right stands on two helical stringers. It rises over 16 ft. to an observation tower above the living room. The design of this double-helix stair was inspired by the Miraculous Staircase (above), which leads to the choir loft of the Loretto Chapel in Santa Fe, N. Mex.

The design and construction of the stair was a group effort that evolved over many months. On hearing the architects' concept for the stair, construction foreman Ivar Eidsmo said he'd seen one just like what they had in mind. He was referring to the Miraculous Staircase in the Loretto Chapel in Santa Fe, N. Mex. (photo below). It was built about 1878 by an itinerant carpenter who appeared out of nowhere, apparently in re-

Eidsmo went down to Santa Fe and photographed the Miraculous Staircase. Although the stair we built is very different structurally and is shorter, narrower and much less ambitious, the Miraculous Staircase did serve as inspiration.

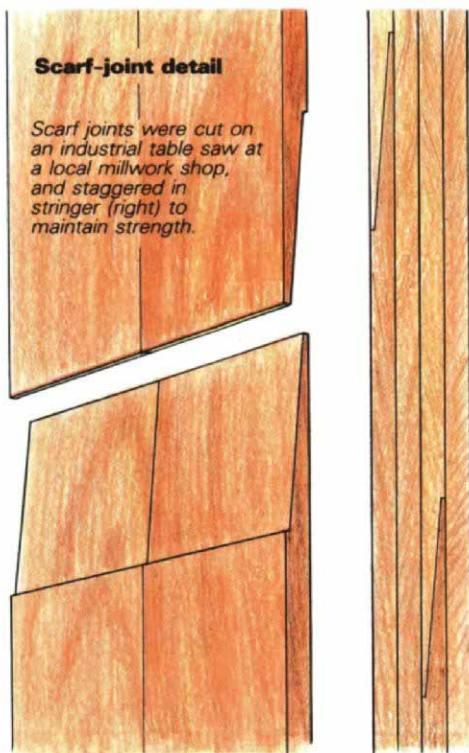
### Scarf-joint detail

Scarf joints were cut on an industrial table saw at a local millwork shop, and staggered in stringer (right) to maintain strength.

Since the stringers are so long (the outside one is nearly 28 ft.), each ply is composed of sections, 6 ft. to 8 ft. long, glued up to form one full-length piece. For maximum strength, the adjoining ends of each ply were scarf-jointed (drawing, top left) on a huge industrial table saw at a local millwork shop.

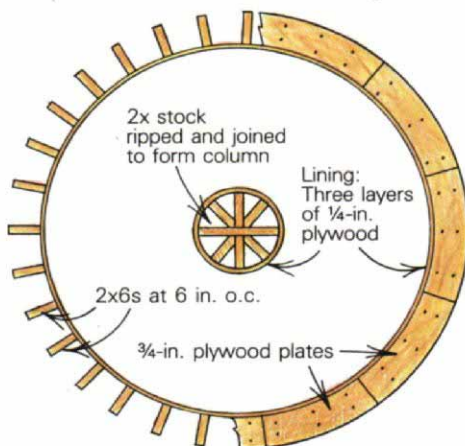
### Plan view of column and cage

We built an inner column of solid 2x fir, and an outer cage encircling it (drawing, middle left). These we wrapped with plywood along the path of the stringers. The cage consisted of vertical 2x6s on 6-in. centers. We used ¾-in. plywood to make the curved plates by bandsawing segments to form a 5-ft. dia. circle.

The column was made with seven pieces of 2x stock stood on end and cut to radiate out from a central axis, like spokes on a wheel, to create a star-shaped cross section with a 12-in. diameter. Three layers of ¼-in. AC plywood were used for the lining, and this is where our wood-bending difficulties began.

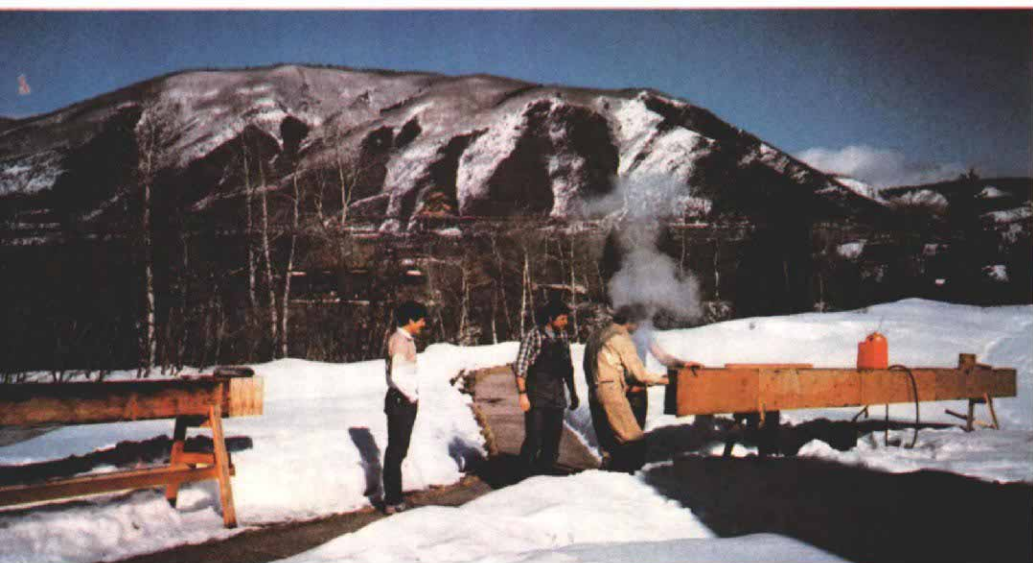
The twisting curves in this stair are so severe that even the thin laminations had to be steamed before they were pliable enough to bend around the forms.

Straight curves are relatively easy to bend, but compound or twisting curves put a much greater stress on the wood, so we had to use steam. Eventually we built three different steamboxes, each one longer than the last. These were simple plywood boxes (6 in. by 14 in.) with a perforated copper pipe running through them, and fed by a 2½-gal. kettle (photo below left). Steaming made the plies supple enough, but once out of the box, the thin wood cooled so fast that we had only seconds to get the piece bent in the form. With the help of several people, we held it there and screwed it to the form with plenty of drywall screws.

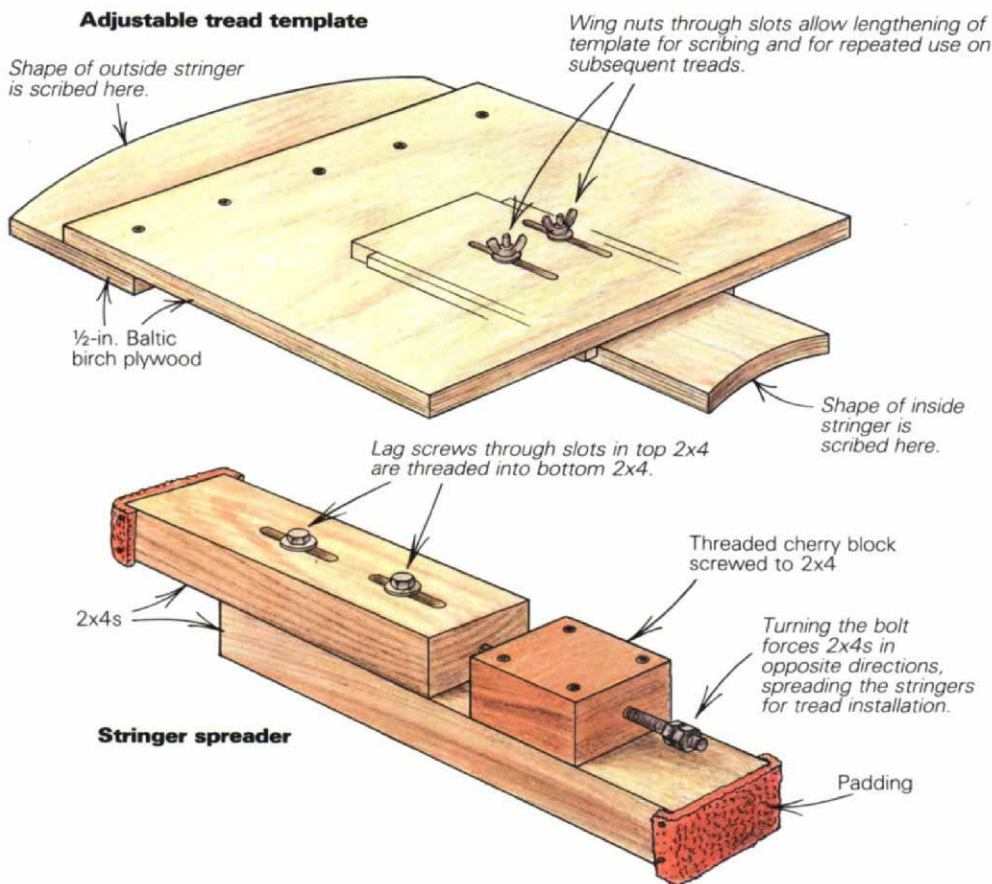
Truck-tire inner tubes, cut up and laced into long bands, were used to clamp the final layer of cherry in place while the epoxy set.

We couldn't use staples on the last veneer so our clamping system changed again. To hold the veneer tight to the stringer during glue-up, we used a series of 2x2 vertical cauls, snugged against the veneer with 30 truck-tire inner tubes. After cutting them into rings and lacing them into bands, we wove the tubing between the treads and around the opposite stringer (photo facing page). This worked amazingly well.

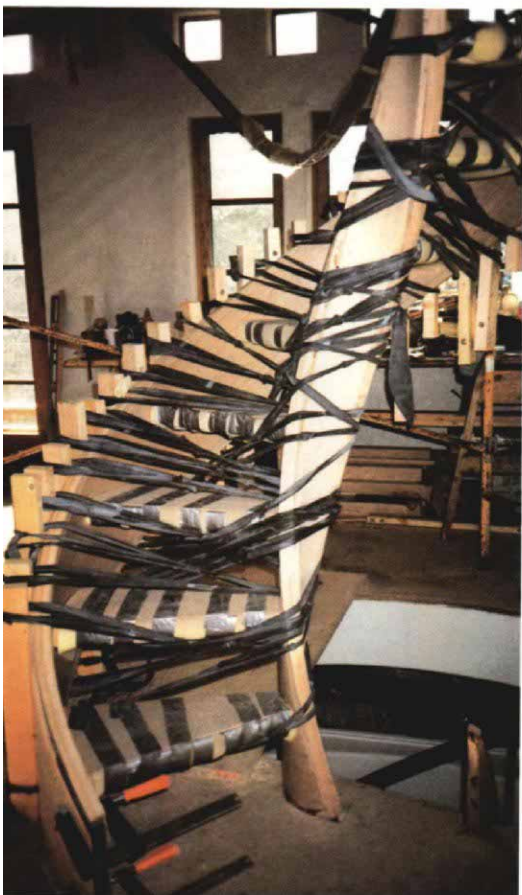
#### Stringer/tread connection

Solid cherry treads were individually scribe-fitted, and treads were installed after the first six laminations were complete.

5/16-in. lamination was cut out around lag bolt and washer.

5/16-in. outer lamination hides lag bolts.

The 5/16-in. layers, next to the outside, were oriented with their grain running at right angles to the other layers.

Caps were glued up of uniform layers and hide the plywood-like composition of the stringers.

In addition, the engineering firm also specified the 2-in. thickness of the treads and their installation details. The treads are held in place by five ½-in. dia. lag bolts 6 in. long—two through the inside stringer and three through the

outside one. The heads of the bolts are concealed beneath the final ply.

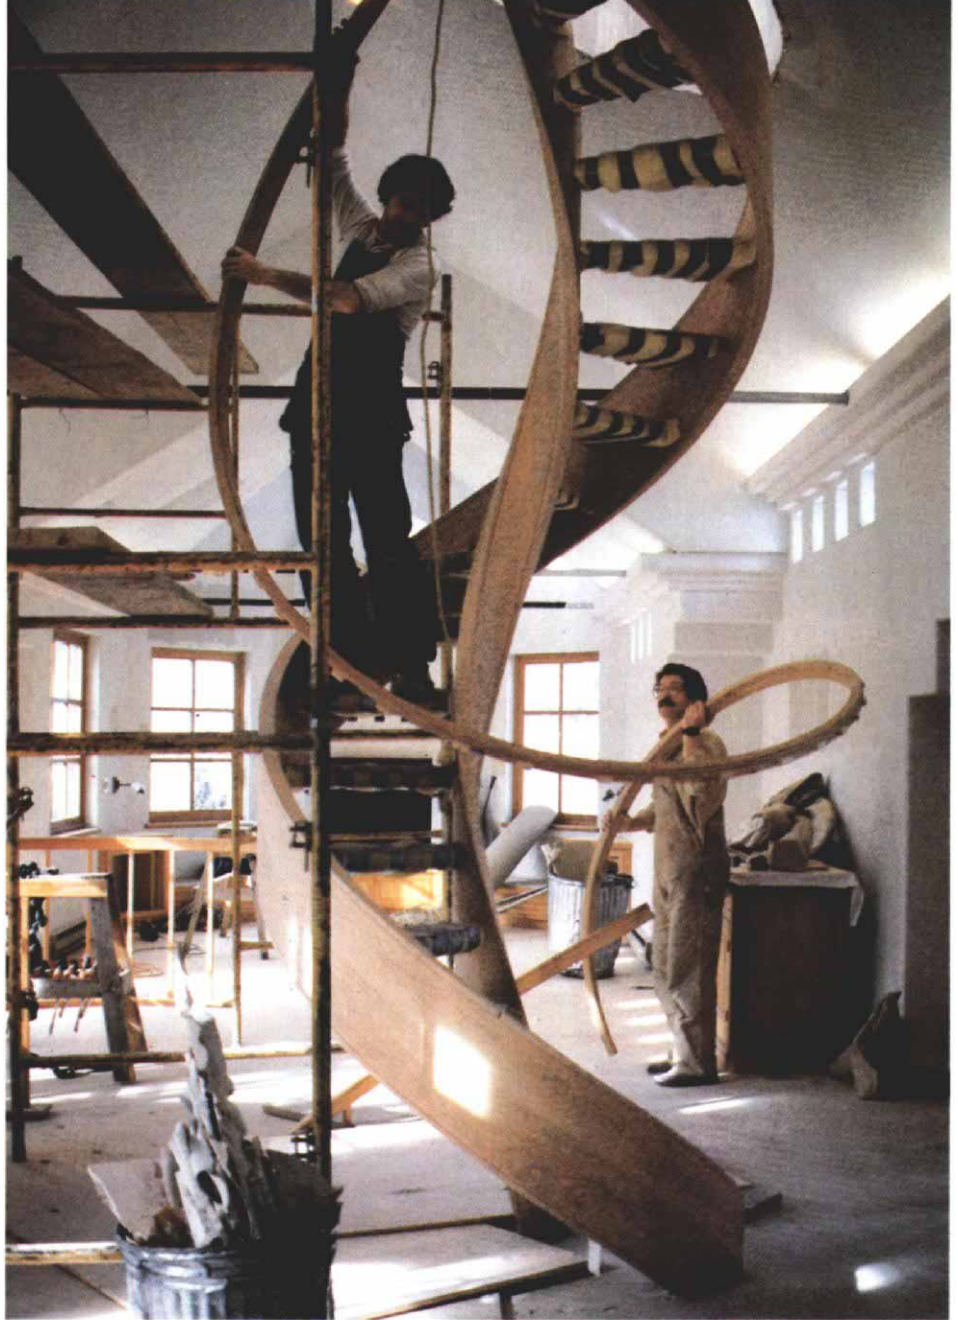
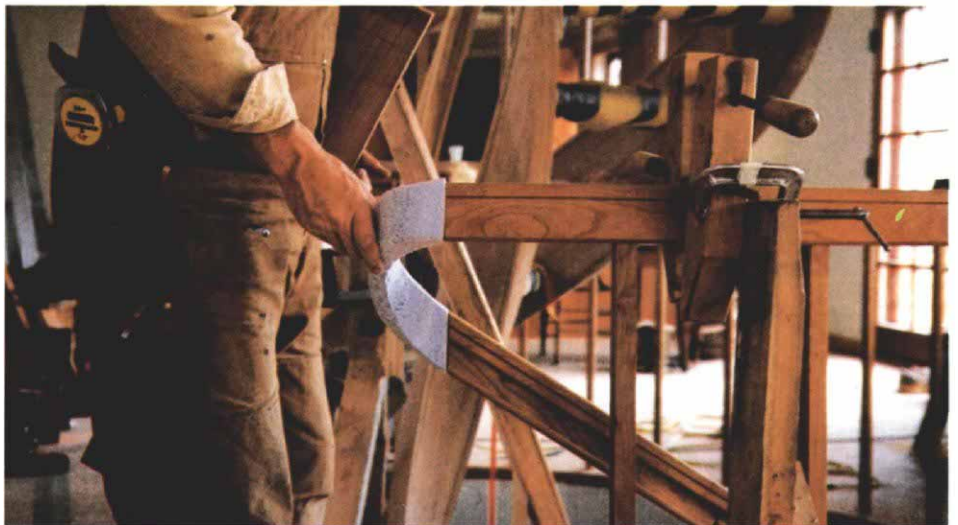
Maneuvering the 28-ft. long handrail into place was like wrestling a giant snake (top). Once it was installed, the builders glued foam blocks in place temporarily (above) to work out the shapes for the transitional sections of handrail.

**Railing and connections**—The handrails had been glued up before the forms were dismantled, but they needed their upper and lower surfaces squared before they could be installed. Trying to work the outside rail required a great deal of patience. At nearly 28 ft. long, 1½ turns and a 5-ft. diameter (photo top right), just getting it clamped was like wrestling a giant snake. Once it was clamped, we could work only a short portion before the twist had us working upside-down and we were forced to reposition it.

After permanently installing all the long sections of rail, we glued the polystyrene chunks in place between the rails with five-minute epoxy and a piece of paper sandwiched between the foam and wood. (The paper allowed us to break apart the glue joints later.) These were then shaped with various saws and rasps to form the final models (photo bottom right).
